CONDITION ASSESSMENT OF POLICE QUARTERS

The main objective this paper is to show the assessment done on an old building situated in Police line Takli, Nagpur. The assessment is based on Ultra Sonic Pulse Velocity test, Rebound Hammer test, Half-cell test, pH test and Cover Meter test, apart from this test Visual inspection is also done. With this assessment the decision can be made whether or which section requires repairs, renovation or replacement.

Name- Lal Imaarat 06

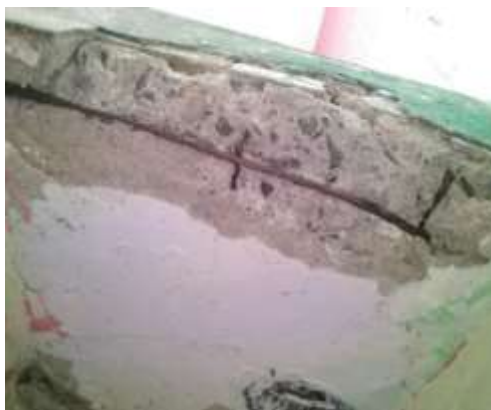
Fig.4.1.1 Reinforcement Exposed in

5. From all the observation and results it is necessary that the existing structure is needed to be repair and retrofitting immediately.

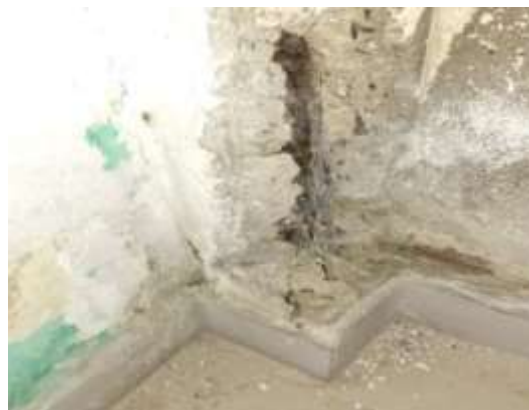
Fig.4.1.2 Deterioration of Column

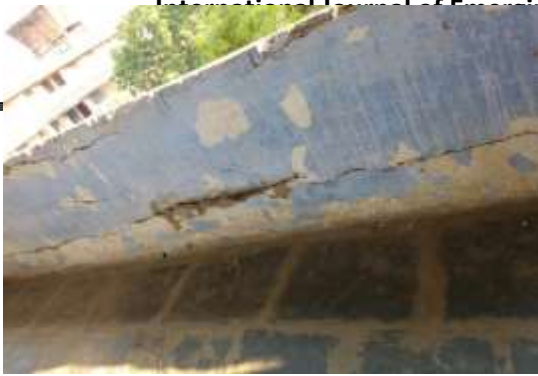
Fig.4.1.3 Cracks in the Parapet Wall

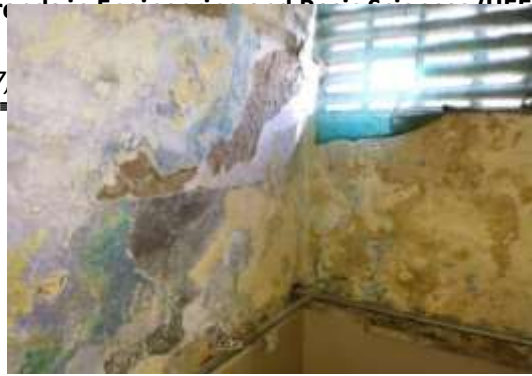
Fig.4.1.4 Seepage in the walls

1. Bad quality of material used while construction.
2. High seepage observed at kitchen, toilet and bathroom walls.
3. High vegetation at the backside of the building, in the kitchen sink, sanitary pipe.
4. High corrosion in column, beam and slab at maximum location.
5. The building has any construction deficiencies.
6. Slab leakage is also observed.

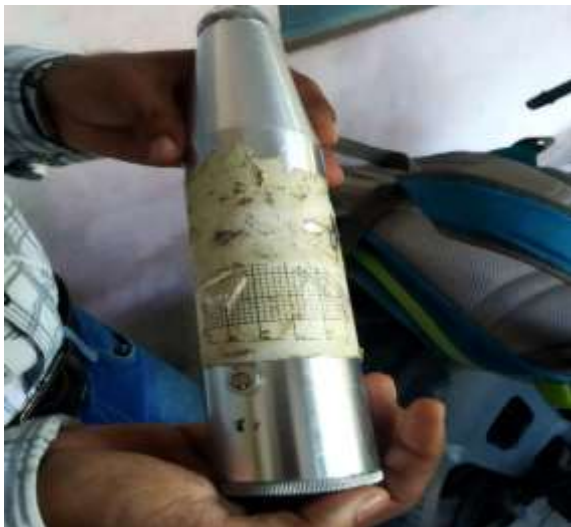
To determine surface hardness of concrete rebound hammer test is carried out. This test is purposed by Swiss engineer Ernst Schmitd. This test is easy to operate, it requires only free surface. The rebound number obtained from rebound hammer used to determined compressive strength of concrete. Compressive strength can be computed from concrete test hammer chart provided by the manufacturer of rebound hammer. The test is not most reliable NDT as it is affected by number of practical factors. The procedure is adopted is as13311:(part II).

Fig. 4.2.1Rebound Hammer Apparatus

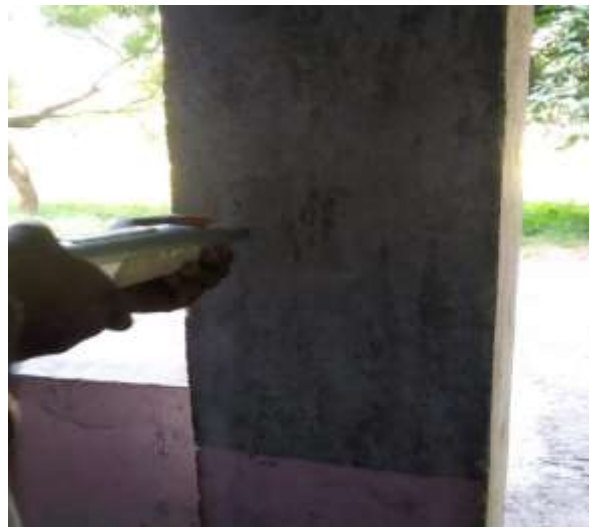
Fig.4.2.2 Testing on Column

2. As per Rebound Hammer Test (Refer to IS 13311(PART II):1992). The readings are in the range of. The quality of concrete is poor concrete.
3. As per pH carbonation concrete maximum corrosion of reinforcement is observed. Carbonation depth has reached up to the reinforcement level. It is observed that the pH of cover concrete is reduced but the passive layer over the reinforcement is intake.

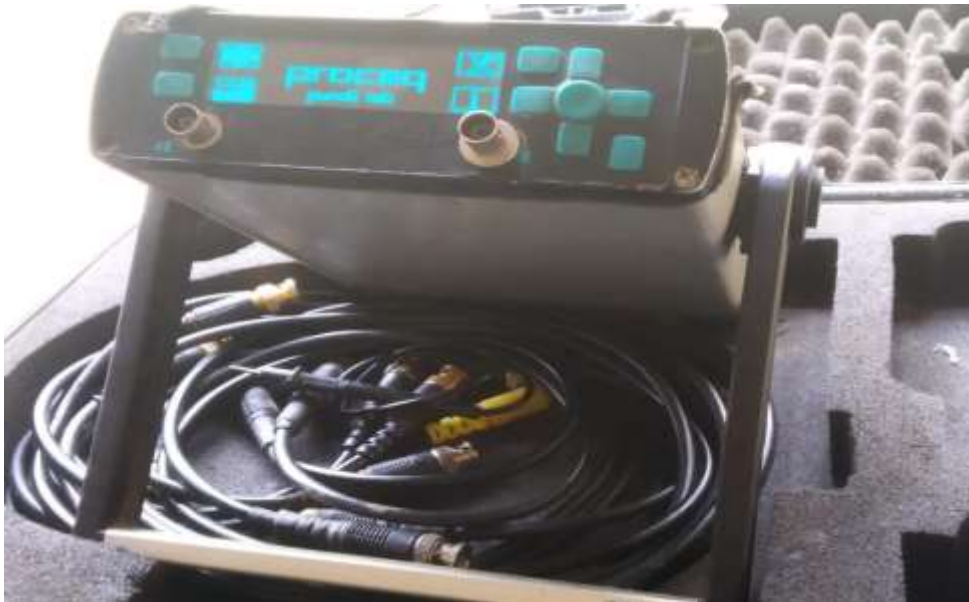
The Ultrasonic Pulse Velocity test carried to determine the homogeneity of concrete and presence of cracks and voids in concrete. The velocity of the pulse through concrete is primarily related to its density and modulus of elasticity. If there is internal crack in concrete, the pulse velocity will be lower as compare to ideal concrete block. The of measurement of ultrasonic pulse velocity are as follows,

Fig. 4.3.1 Ultrasonic Pulse Velocity Apparatus

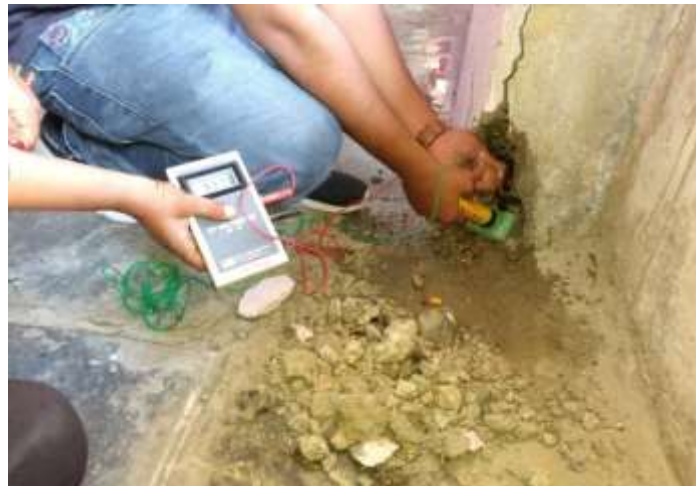
Half-cell Test is performed to determine the severity of corrosion activity in reinforcement. A voltmeter is connected between the reinforcement and Cu-CuSO₄ reference electrode the concrete surface. The test is derived from the fact that reinforcing steel and surrounding concrete acts as a half cell of the battery cell

Fig. 4.4.1 Half-cell Testing

4. As per the Half Cell potentiometer test on reinforcement it is observed that all the readings are ranged from this indicates corrosion has started in reinforcement and exceed the acceptable limit.

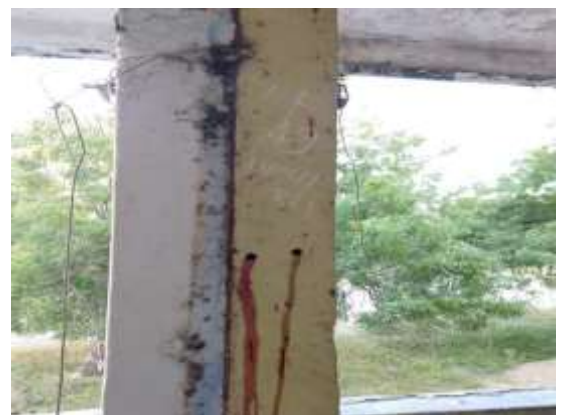
Carbonation of concrete occurs when carbon dioxide from air and water reacts with calcium hydroxide present in concrete to form calcium carbonates. Carbonation in concrete is a threat to durability and strength of concrete. Carbonation reduces the pH of concrete and increases its porosity. Carbonation may penetrate slowly from concrete surface but presence of cracks in structure will increase the rate of carbonation as the cracks provides passage for water and contamination. The method to determine the extent of carbonation in concrete requires solution of Phenolphthalein and Ethanol diluted in distilled water. The solution is sprayed on a fresh fracture surface of concrete. In case of non-carbonated concrete the indication colour will be pink and for carbonated concrete it will be colourless.

Fig.4.5.1 Depth of Carbonation

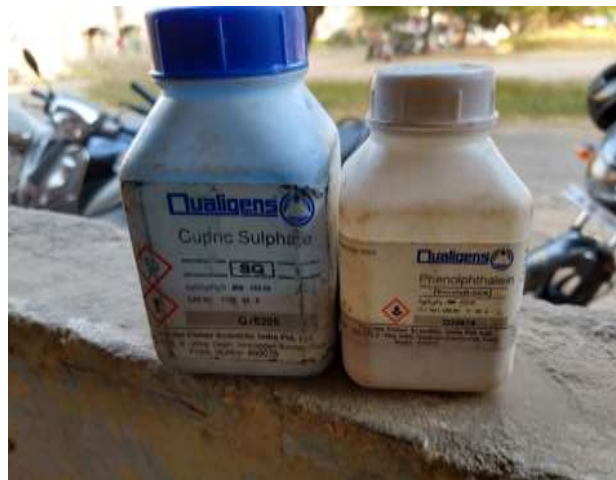
Fig.4.5.2 Phenolphthalein Indicator

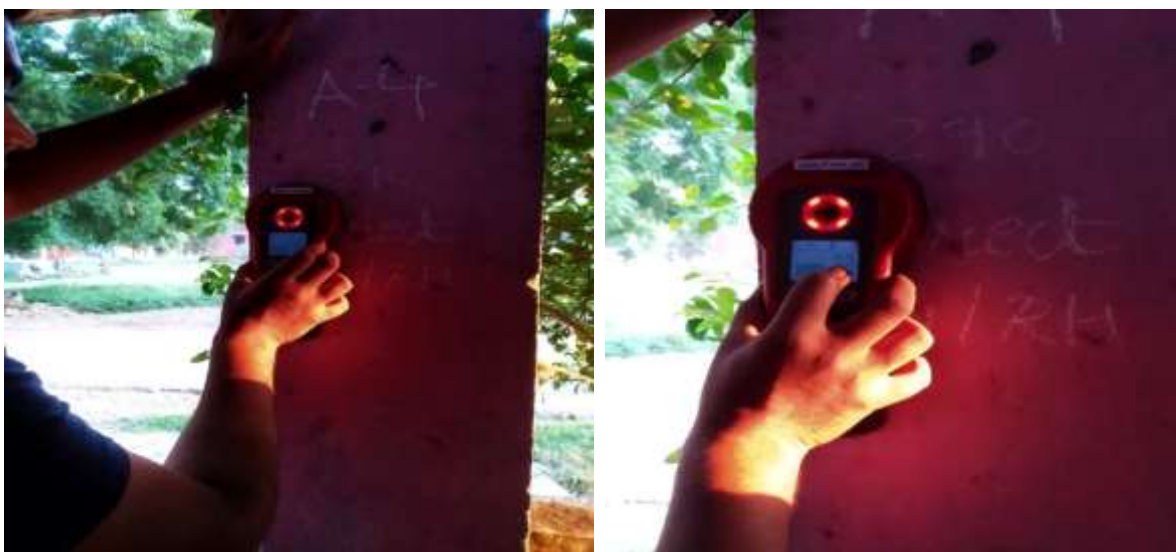
A cover meter is a device which is used to determine the cover provided in the concrete. Cover is the distance measured from the concrete surface to the nearest surface of the reinforcing bar. The cover meter is based on electromagnetic pulse induct technology to detect reinforcement. Cover meter test is very useful where structural drawing is not available. The protection of rebar from corrosion depends on cover provided.

Fig. 4.6.1 Cover Meter Testing
